Manhole Inspection Summary

Manhole # S21YY1018MH

Insp Date: **11/27/06 3:28 PM**

Location Address: **FALLS RD**

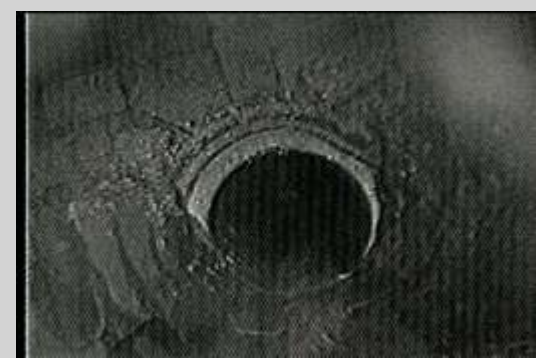
8 in. Circular Gravity Sewer Pipe Out @ 12 O'Clock

Pipe Material: **Clay** ☐ Pipe Lined

Infiltration: **None** Pipe Seal Cond: **Unknown**
